## **Aviation Investigation Preliminary Report**

Location: Anderson, IN Accident Number: CEN24FA340

Date & Time:September 6, 2024, 09:48 LocalRegistration:N629AG

Aircraft: PIPER AIRCRAFT INC PA 46-350P Injuries: 4 Fatal

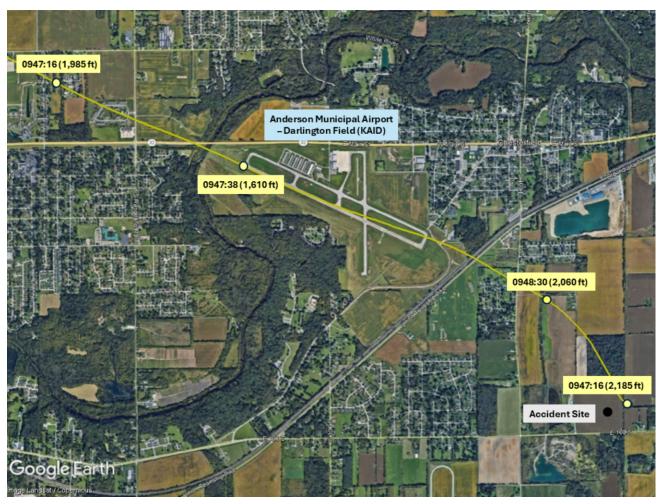
Figure 1 - Final Segment of Airplane Flight Path

About 0947:16, when the flight was 0.9 miles west of the runway and about 1,985 ft msl, the pilot informed the controller he needed to go around. The controller subsequently cancelled the approach clearance and instructed the pilot to turn right to a heading of 180° and climb to 3,000 ft msl. The airplane continued toward the airport, and at 0947:38, crossed the runway 12 threshold about 1,610 ft msl [730 ft above ground level (agl)]. The airplane flight track drifted slightly north-northeast of the runway centerline. About 0948:30, the airplane appeared to start a gradual right turn. At that time, the airplane was about 0.60 miles southeast of the departure end of runway 12 at an altitude of about 2,060 ft msl. The final ADS-B data point was recorded at 0948:55 with an associated altitude of 2,185 ft msl (1,349 feet agl).

A witness, located about one-quarter mile from the accident site, observed the airplane come up above a tree line in a climb. Shortly afterward, the airplane stopped climbing "all of a sudden", rolled to the right, and entered a descent. The engine was loud and sounded like it was "really revving;" adding that it seemed to be wide open.

A second witness, located about one-eight mile from the accident site, reported hearing the airplane engine "revved up", decreased, and then "revved up" again, before it cutout. He did not hear the sound of the impact with the ground.

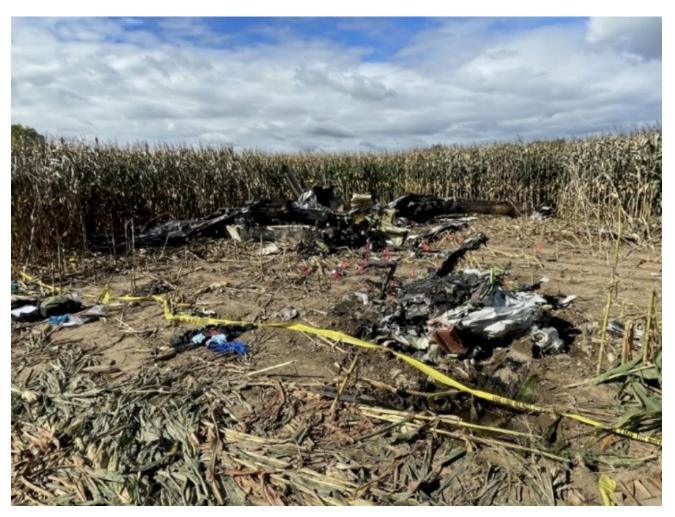
Figure 2 – Airplane Wreckage at Accident Site

The accident site was located in a corn field about 1 mile southeast of the departure end of runway 12 at an elevation of 923 ft. This was about 547 ft southwest from the final ADS-B data point. The airplane came to rest upright on a northeast heading. The debris area extended about 50 ft southwest from the initial impact. The airframe was fragmented, and portions were consumed by a postimpact fire. The engine and forward fuselage were located adjacent to a 4-foot diameter impact crater. All three propeller blades were separated at the blade roots and positioned near the crater. The cockpit area was located about 12 feet from the forward

fuselage. The wings and center fuselage were positioned about 15 feet from the cockpit debris. The aft fuselage and empennage were located in position adjacent to the wings. Both main landing gear struts were in the extended position; the nose landing gear was separated.

Major airframe structural components were located at the accident site. Portions of the airframe were consumed by the postimpact fire. Each flight control surface, including both wing flaps, either remained attached to the airframe or was separated and located within the debris path. The wing flap actuator was not observed and the flap position at the time of the accident could not be determined. However, based on the examination of the available wreckage, no evidence of an inflight structural failure was observed. The airplane was retained by the NTSB for further examination.
